Before 1890

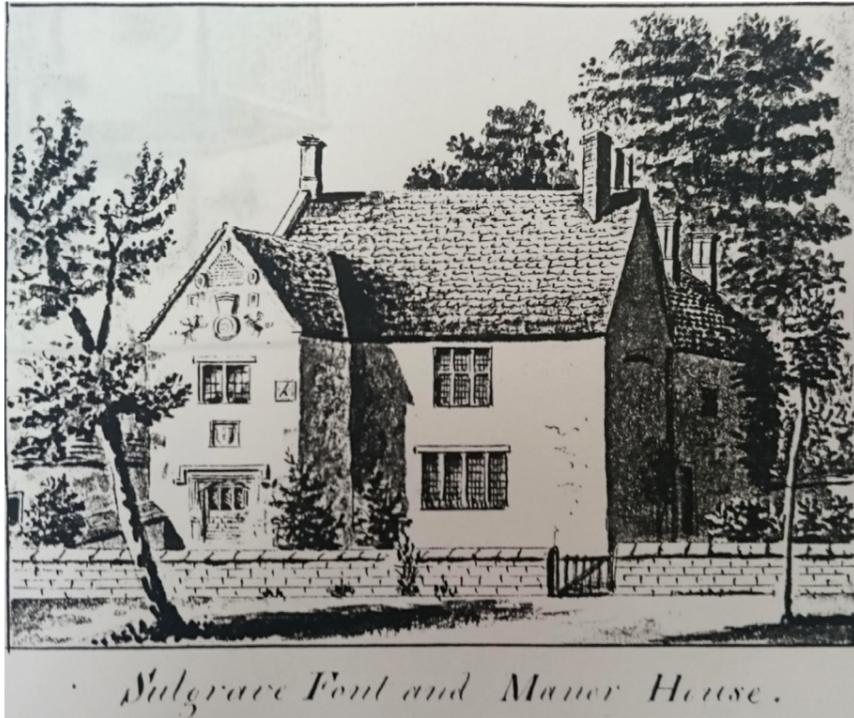
Earliest known image of Sulgrave Manor, c1844. Depicts the south elevation and shows the porch doorway partially bricked up with windows above. It was in use as a dairy window, a function described by Albert Welles in 1879. The caption references “Sulgrave Font,” but the meaning of “font” at Sulgrave is unknown. (Northants Record Office)

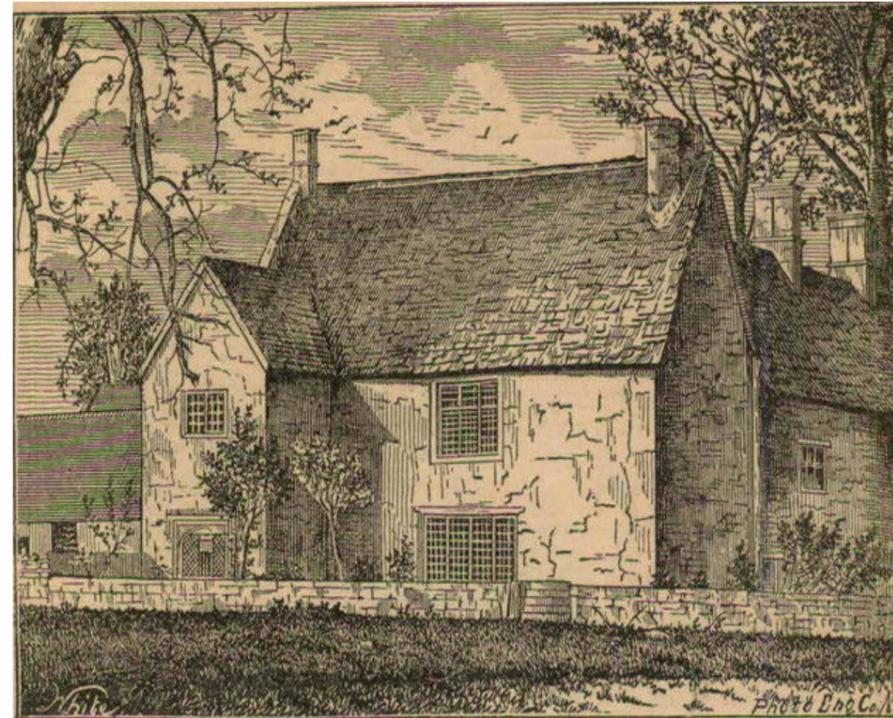
Engraving made from an unknown photograph for the American Centennial Exhibition, c1876. The inclusion of Sulgrave in this American celebration indicates that the site was already important on both sides of the Atlantic. The lines covering the building’s surface represent the render that previously coated the house. (Centennial Exhibition)

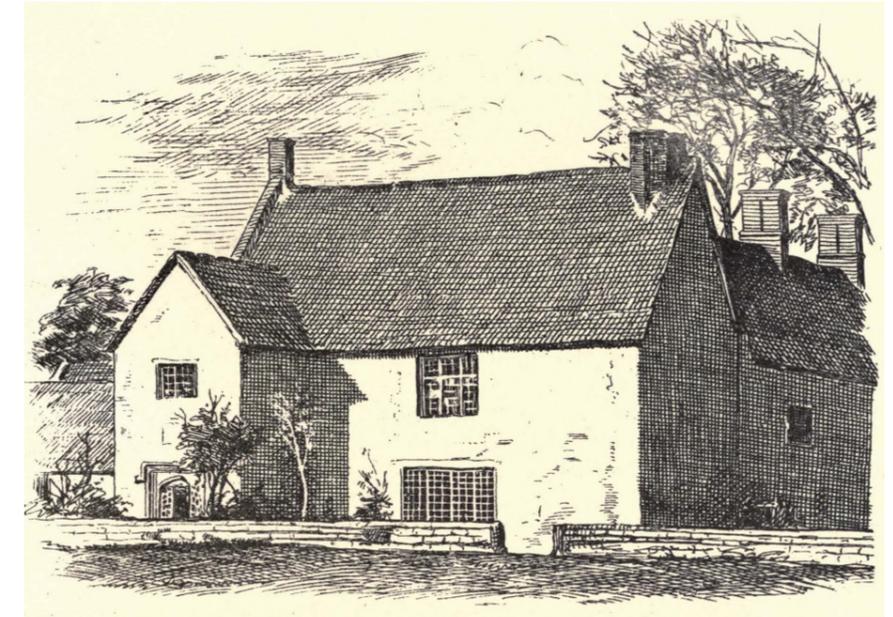
South elevation, printed 1879. Note the large bedchamber window: this was changed to the current smaller one around 1920 in Sir Reginald Blomfield’s first phase of restoration and garden work at Sulgrave. Blomfield also changed the lower window to one with a thick horizontal transom all the way across. (Welles)

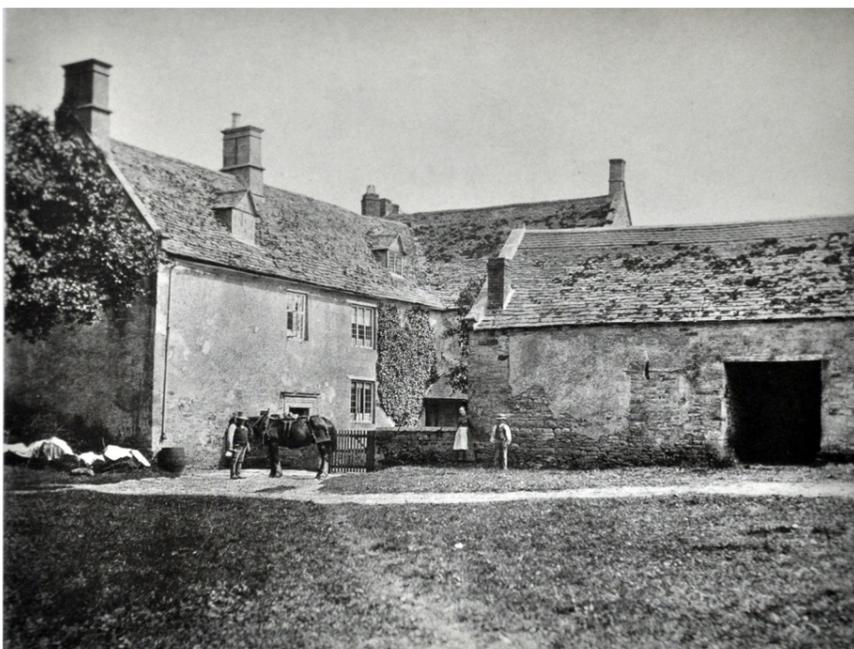
Earliest known view of north side of Manor and Brewhouse, around 1880. Note presence of only two dormers on north wing, the awning over the door to the main stairwell (in corner of courtyard), the render covering the Manor walls, and the large stall-style door and the chimney on the Brewhouse. These elements will all change or disappear in later images. (SM)

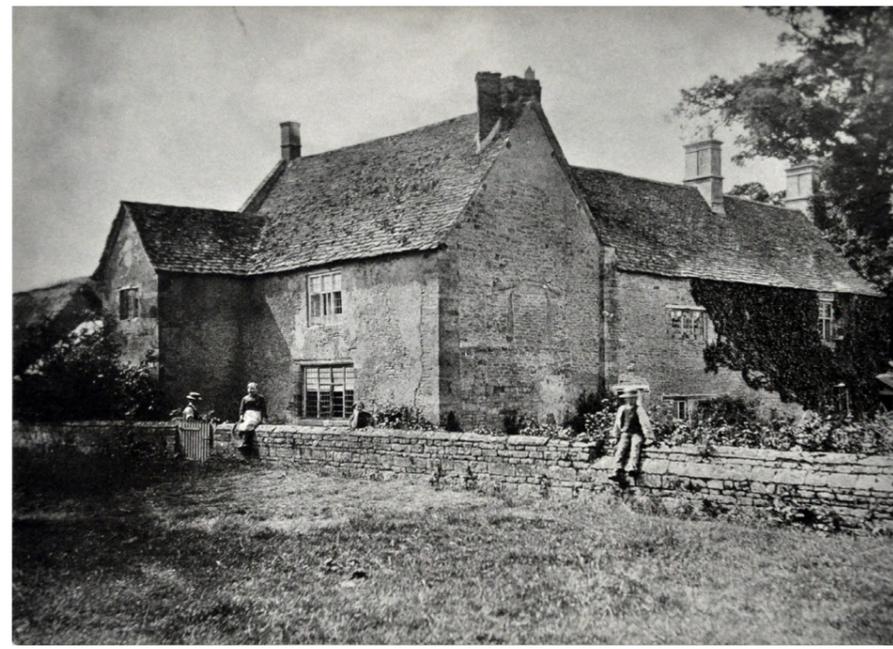
Southeast view of Manor around 1880. The east wall is particularly interesting. The remains of a Tudor fireplace are visible on the first floor (as they still are today). There is also an indication of a wall that originally extended further to the east, visible in the small projection of stone at the junction between the Tudor and later wing. (SM)

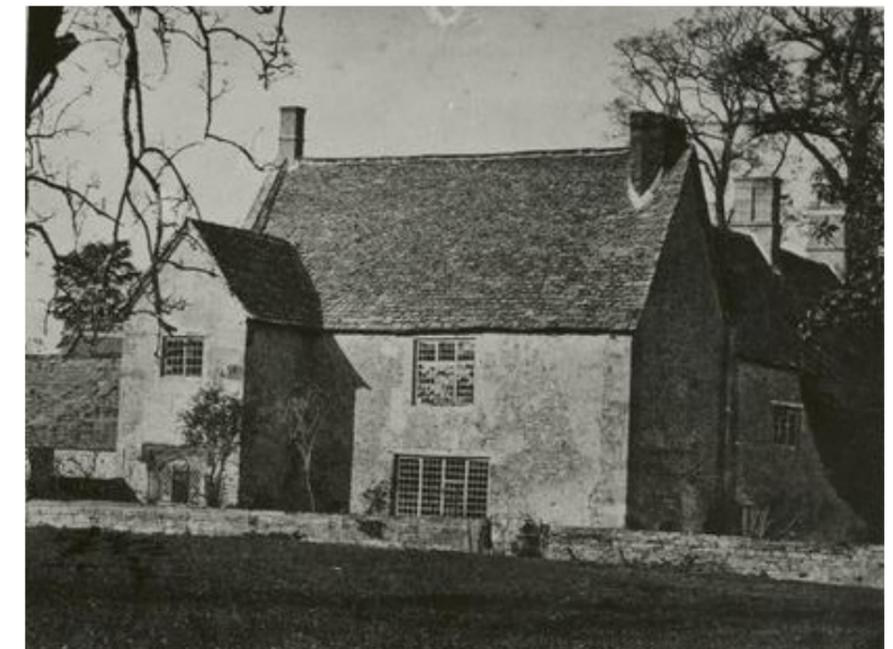
Photograph of southeast view of Manor that appears to show the dairy window in the porch. Three panels are visible in the opening. The outer two look like they have diamond patterns as shown in the 1876 engraving above. An 1891 image shows a plain door, so this photograph is likely pre-1890. (NYPL)

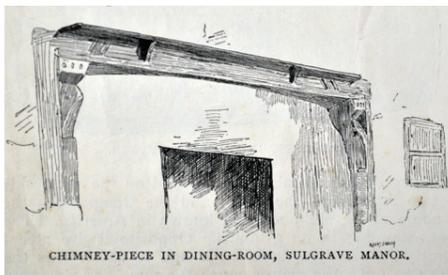
Left: This sketch depicts the mantel of the fireplace in the “dining-room,” but the presence of Lawrence the Builder’s small cupboard confirms that this is the Great Hall. The large fireplace is partially filled in. (Clarke, 1891)

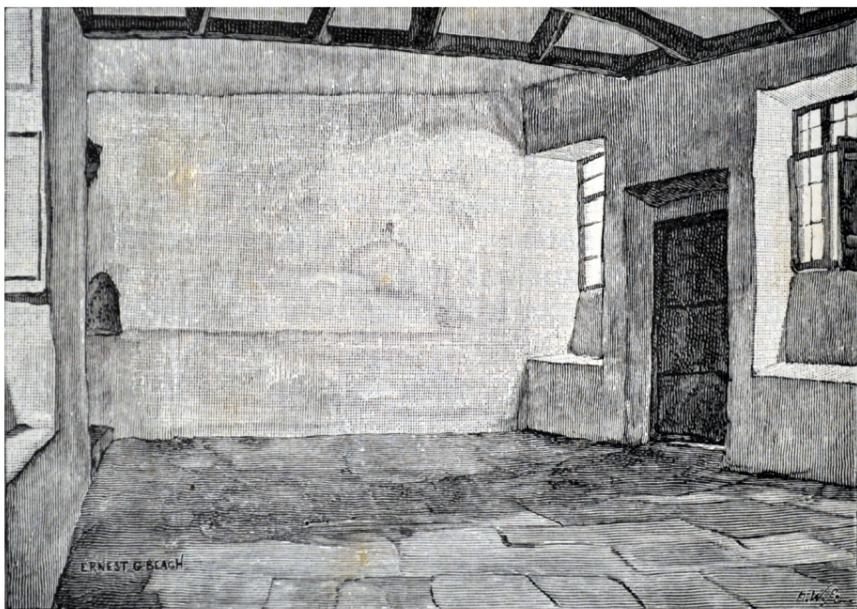
View of the Great Hall as “The Dairy,” 1891. This image is confusing because in Clark’s account, the author writes that this room was formerly divided into two parts, one being this dairy, but that the partition has been removed. However, a partition is visible in photos from the 1910s and later accounts describe it being there. (Clark)

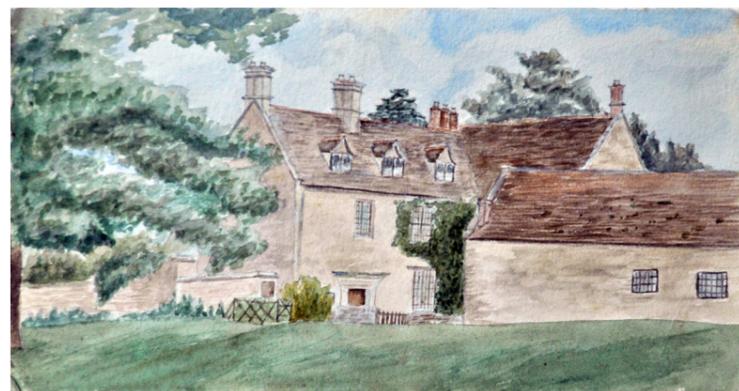
1898 watercolour of north side. This is the first appearance of the long shed along the north gable end. Three dormers also present for first time. Clarke describes the house as having three in 1891, meaning that the middle one was added between 1880 and 1891. (SM)

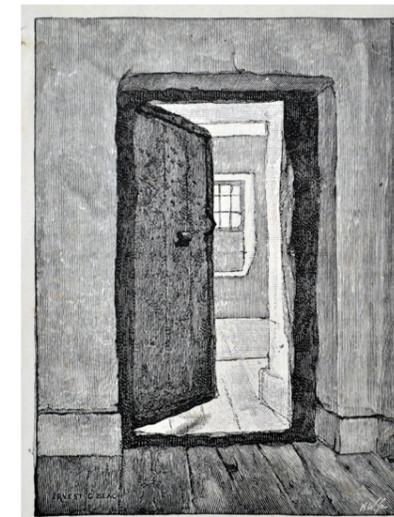
Left: Clarke describes this image as “Door to Bedroom” but his description of the manor leaves some uncertainty as to which bedroom this might be. It seems to be looking into the room above the porch from the current Deed Room. (1891)

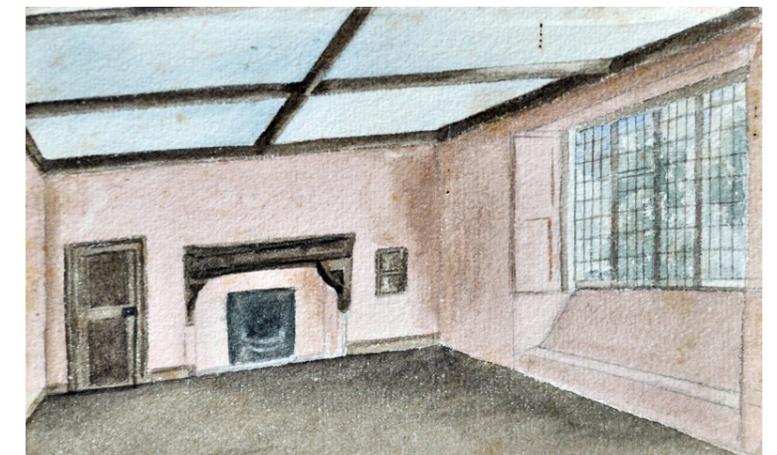
1898 watercolour of the hall. An interesting image for the way that it presents the ceiling of the hall: fewer beams are shown than there are today. This indicates that Blomfield added or uncovered more in 1920, but why? Did the Tudor house have more beams that had been lost over the years? (SM)

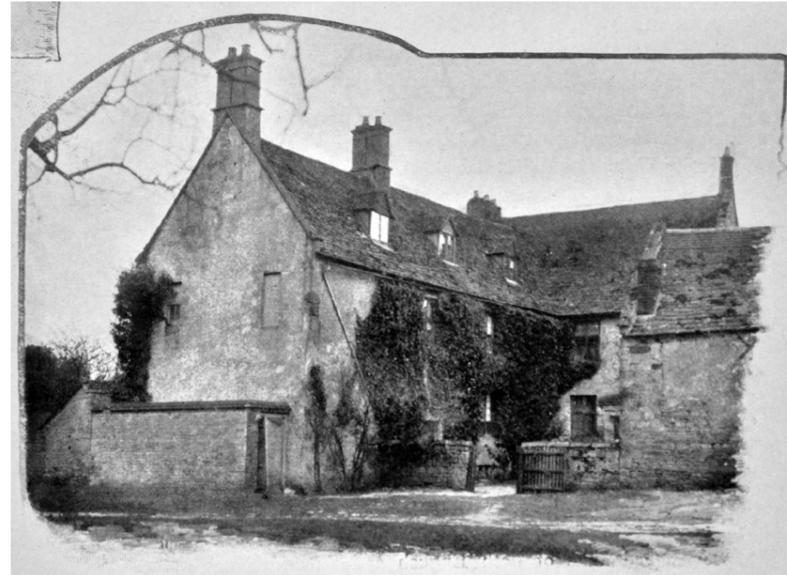
View of north wing and shed with lean-to, printed 1901. Note filled-in right window and partially filled large left window space with a much smaller one inside on north wall. (Branscombe)

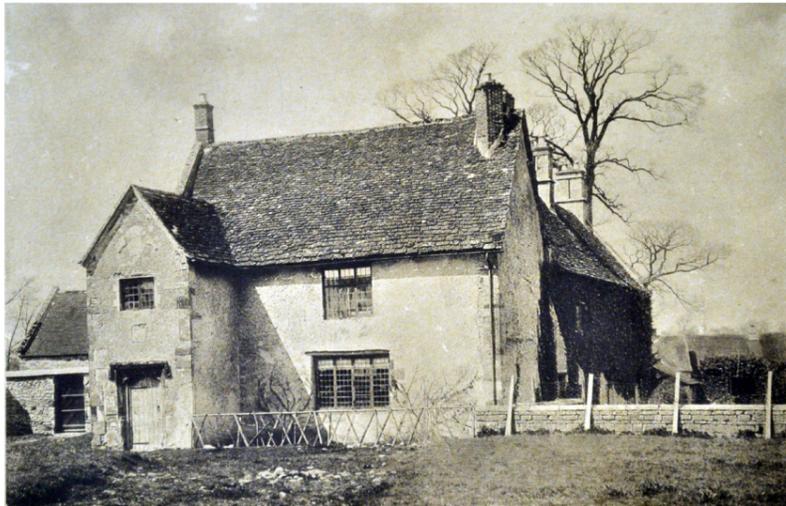
South elevation, copyright 1900. Wooden fence remains but is in poor condition. It was replaced with a stone wall again by at least 1903, possibly 1901. (SM)

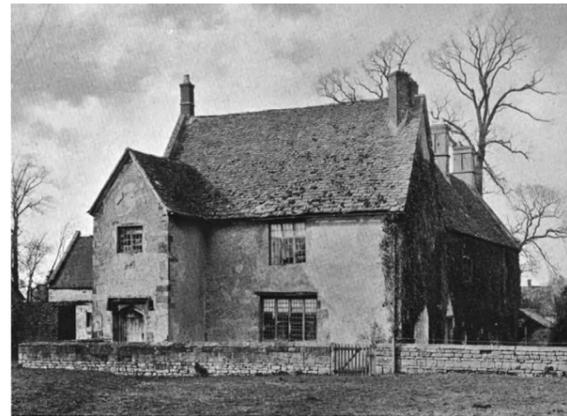
South Elevation, printed 1903. The stone wall is once again covering the whole front of the house after being replaced by a wooden cross fence since at least 1891. (Leyland)

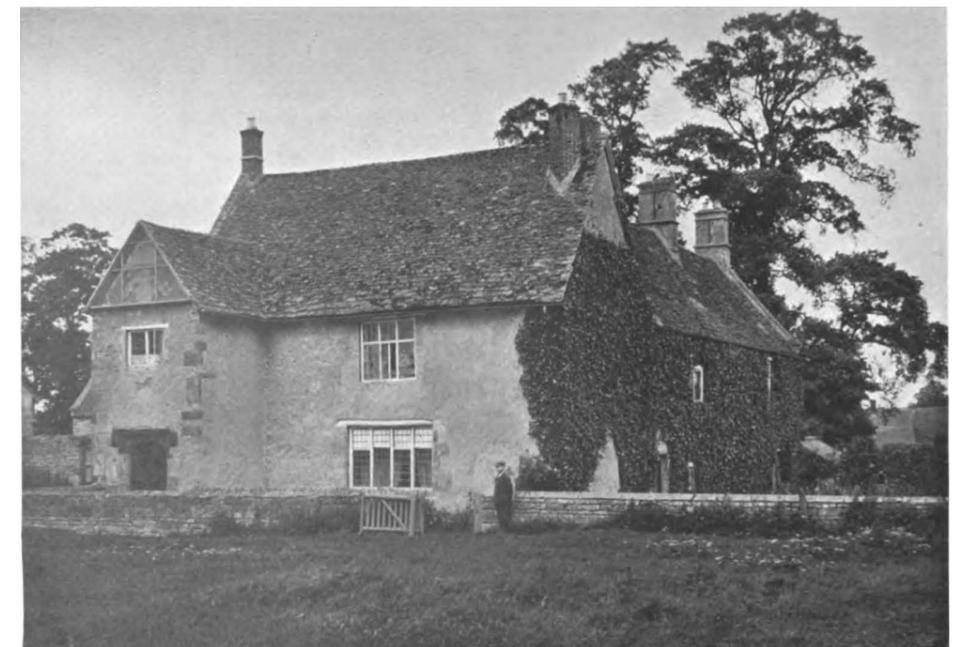
Printed 1908. Earliest known appearance of the protective glass covering of the wool symbol and the Royal Arms on the porch gable. (Story)

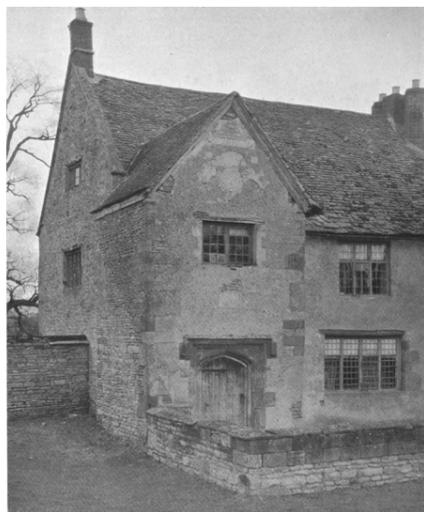
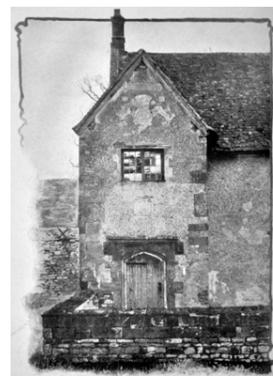
Porch details, printed 1901 (above, Branscombe) and 1903 (left, Leyland, also showing west face). Note wooden door in outer frame of porch.

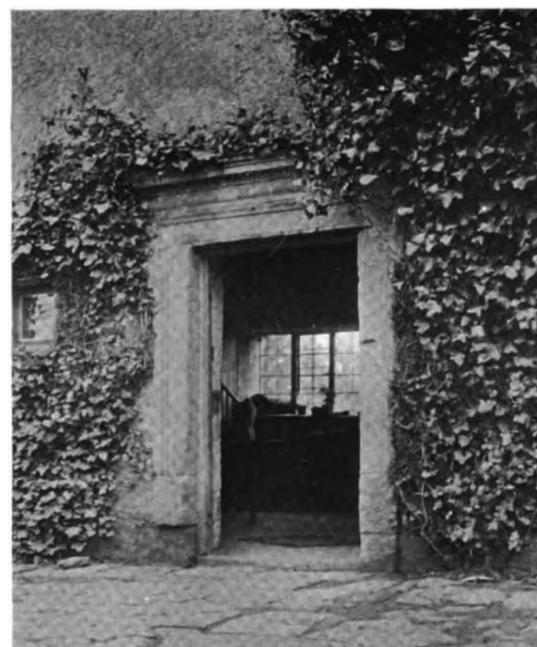
Painting by Daniel Sherrin, printed 1910. Glass not shown and bedchamber window appears shorter than it should, but it is still correctly shown with three lights. However, transom on lower window is there when it should not yet be present. (Murphy)

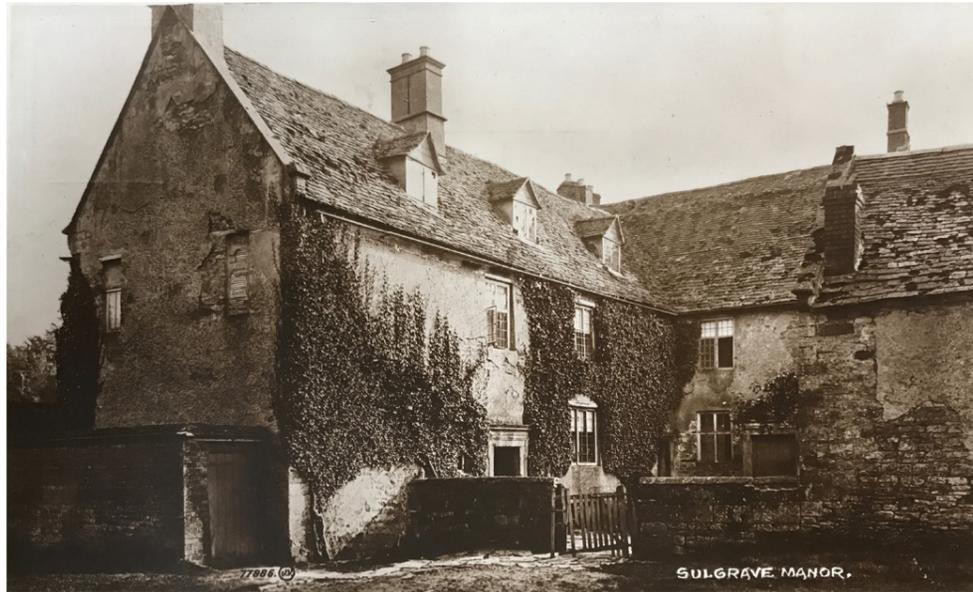
Northwest elevation. Note visible lathe on the right window of north wall. (SM)

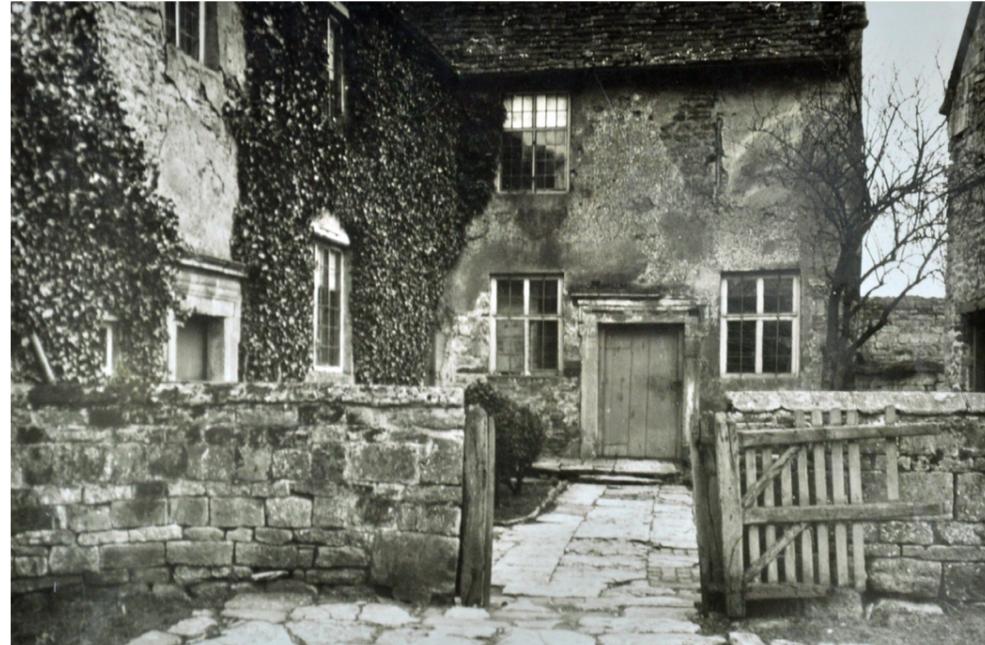
Northwest courtyard, 1912. Before Blomfield's restoration of the Great Hall. Partition wall is visible through lower window to the left of the door. Also shows blocked in upper right window, small window by kitchen door and door on Brewhouse. (SM)

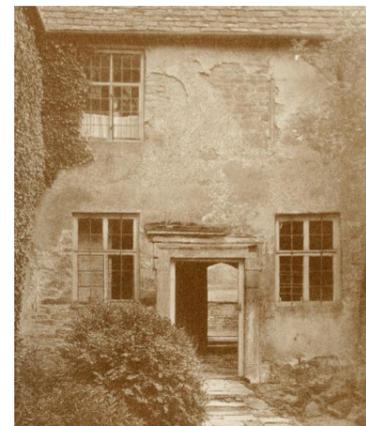
View through NW courtyard door and porch to south side of house. The hall was still partitioned and this door still in use. Published 1920. (Hutchinson)

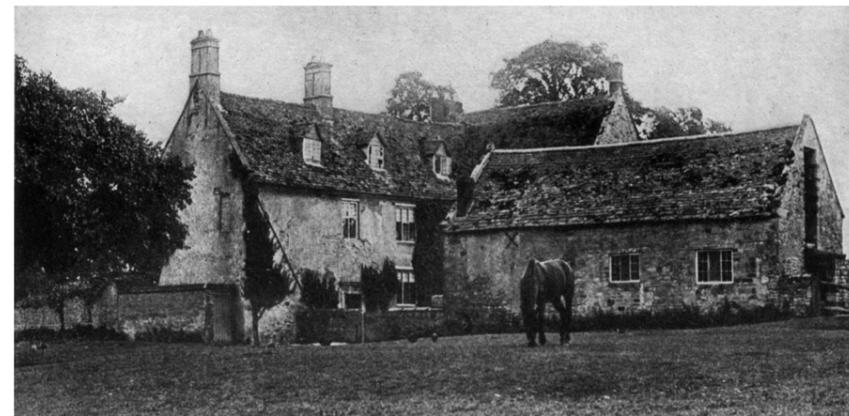
Northwest view, c1915. Shows shed on north face and wall extending behind it. Also shows blocked right window on north wall. (Wharton)

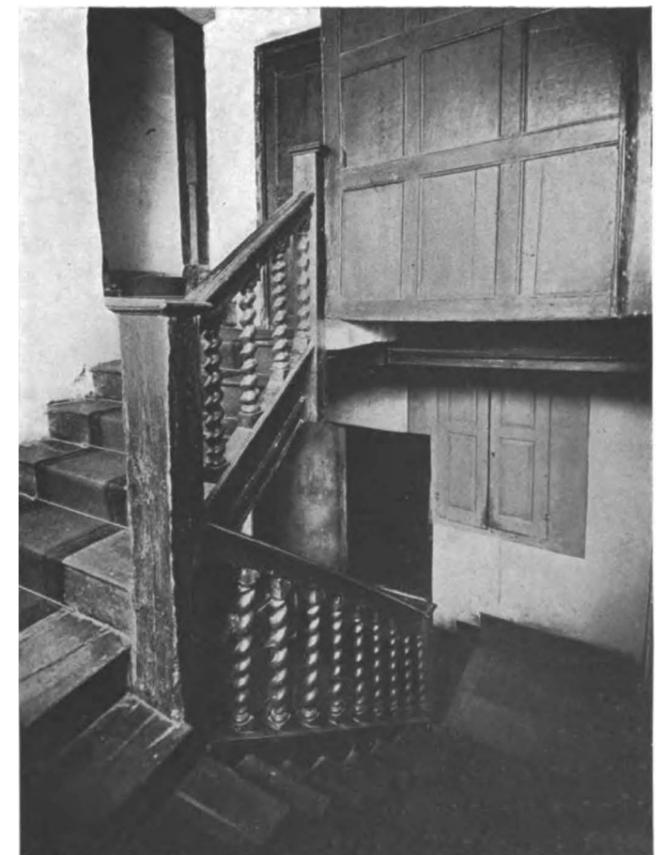
Main staircase, printed 1915. Staircase is likely mid to late 17th century due to presence of barley twist balustrade. Recessed wall cupboard on lower landing is slightly further to the left than it is today. This was probably once a window, and suggestive lines are visible in exterior stone as well. The closet at the top of these stairs contains a blocked-in window and is claimed by some sources as Queen Elizabeth I's rumoured hiding place at Sulgrave, though others believe it was the attic above the porch. (Wharton)

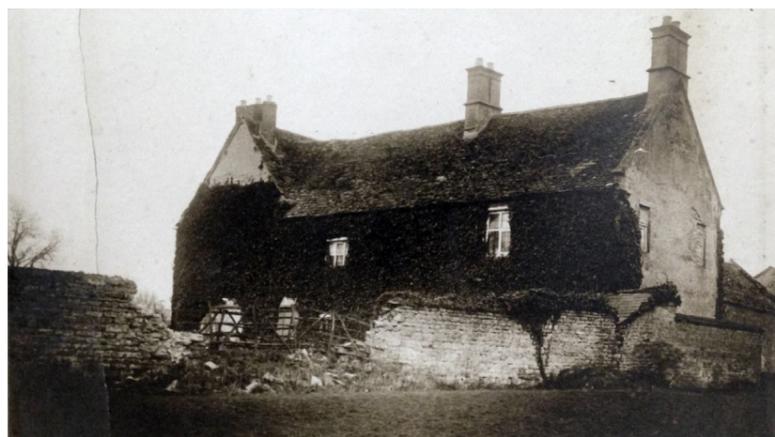
Right: Northeast view of Manor, 1910s. Note the crumbling stone wall and overgrown ivy. The Manor had grown quite dilapidated by the early twentieth century. (SM)
